USAAEFA PROJECT NO. 77-04

**ARMY PRELIMINARY EVALUATION
YAH-1S HELICOPTER WITH MODIFIED
FLAT PLATE CANOPY INSTALLED**

FINAL REPORT

UNITED STATES ARMY AVIATION ENGINEERING FLIGHT ACTIVITY
EDWARDS AIR FORCE BASE, CALIFORNIA 93523

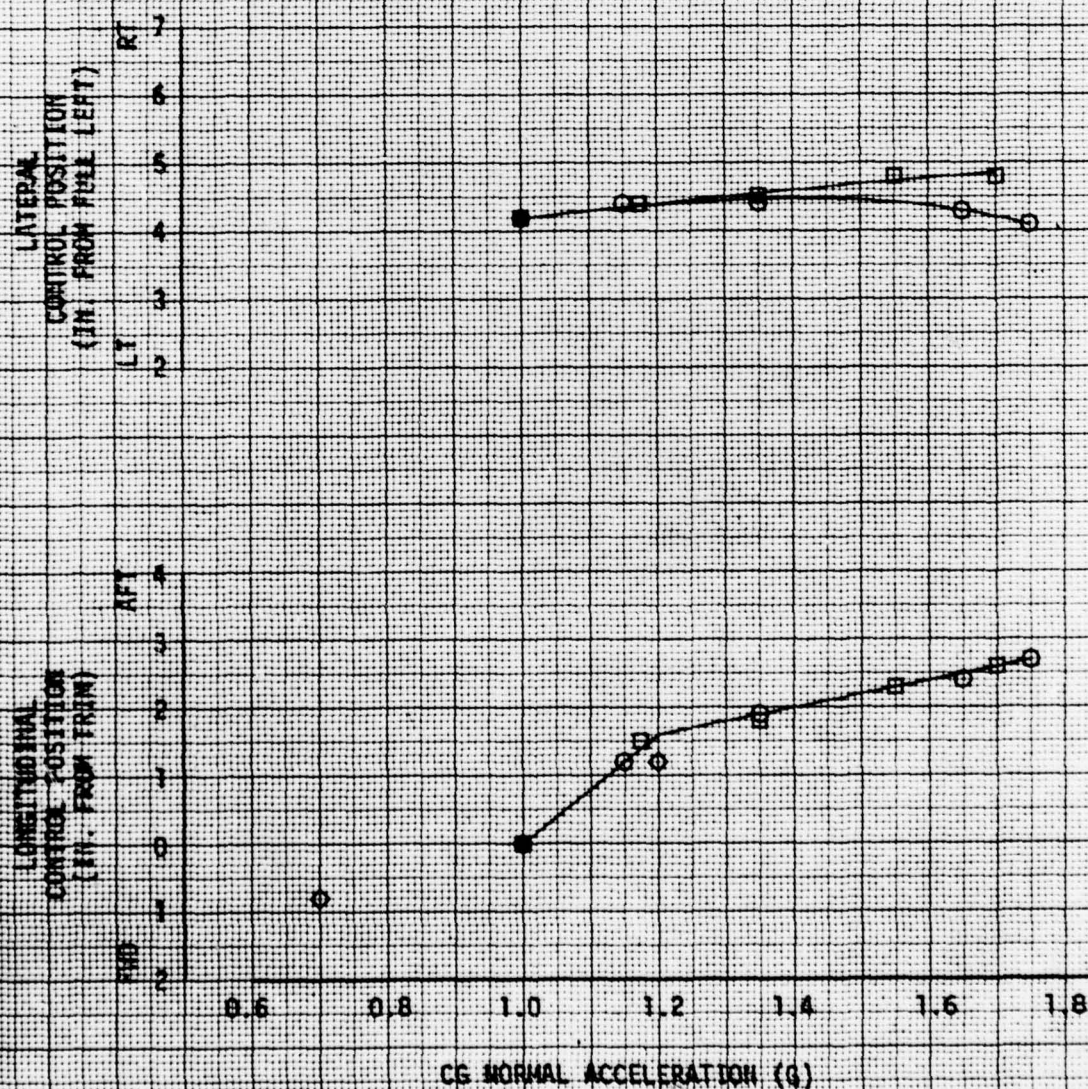
FIGURE 20
MANEUVERING STABILITY

- NOTES: 1. SHADED SYMBOLS DENOTE TRIM POINT AT 1225 SHP.
2. SCAS ON.
3. K-747 ROTOR INSTALLED.
4. ZERO SIDESLIP TRIM CONDITION

TRIM CALIBRATED AIRSPEED = 64 KNOTS

28. Maneuvering stability characteristics were quantitatively evaluated at the conditions listed in table 1, utilizing the technique described in appendix D. The tests were conducted with the K-747 rotor installed and at high engine power settings (94 percent torque at 64 KCAS and 88 percent torque at 105 KCAS). Test results are presented in figures 20 and 21, appendix E. The variation of longitudinal control position with normal load factor was positive (aft control movement with increasing load factor) and essentially unchanged from the AH-1G. The discontinuity in the variation of longitudinal control position with normal load factor was probably caused by the effective loss of SCAS input due to full actuator extension (ref 16, app A). At 64 KCAS (left and right turns), the aircraft was easy to control and precise airspeed control was accomplished with minimal pilot effort. At 105 KCAS, and above approximately 1.35 normal load factor, precise airspeed control became very difficult due to a longitudinal oscillation. Although the pilot had difficulty in maintaining precise trim airspeeds, no divergent tendencies were noted. This longitudinal oscillation was probably caused by the effective loss of SCAS input, as mentioned above. The decrease in maneuvering stability at higher airspeeds and above 1.35 normal load factor increased pilot workload in maintaining precise trim airspeeds at high angles of bank, but this characteristic will not adversely affect mission maneuvers.

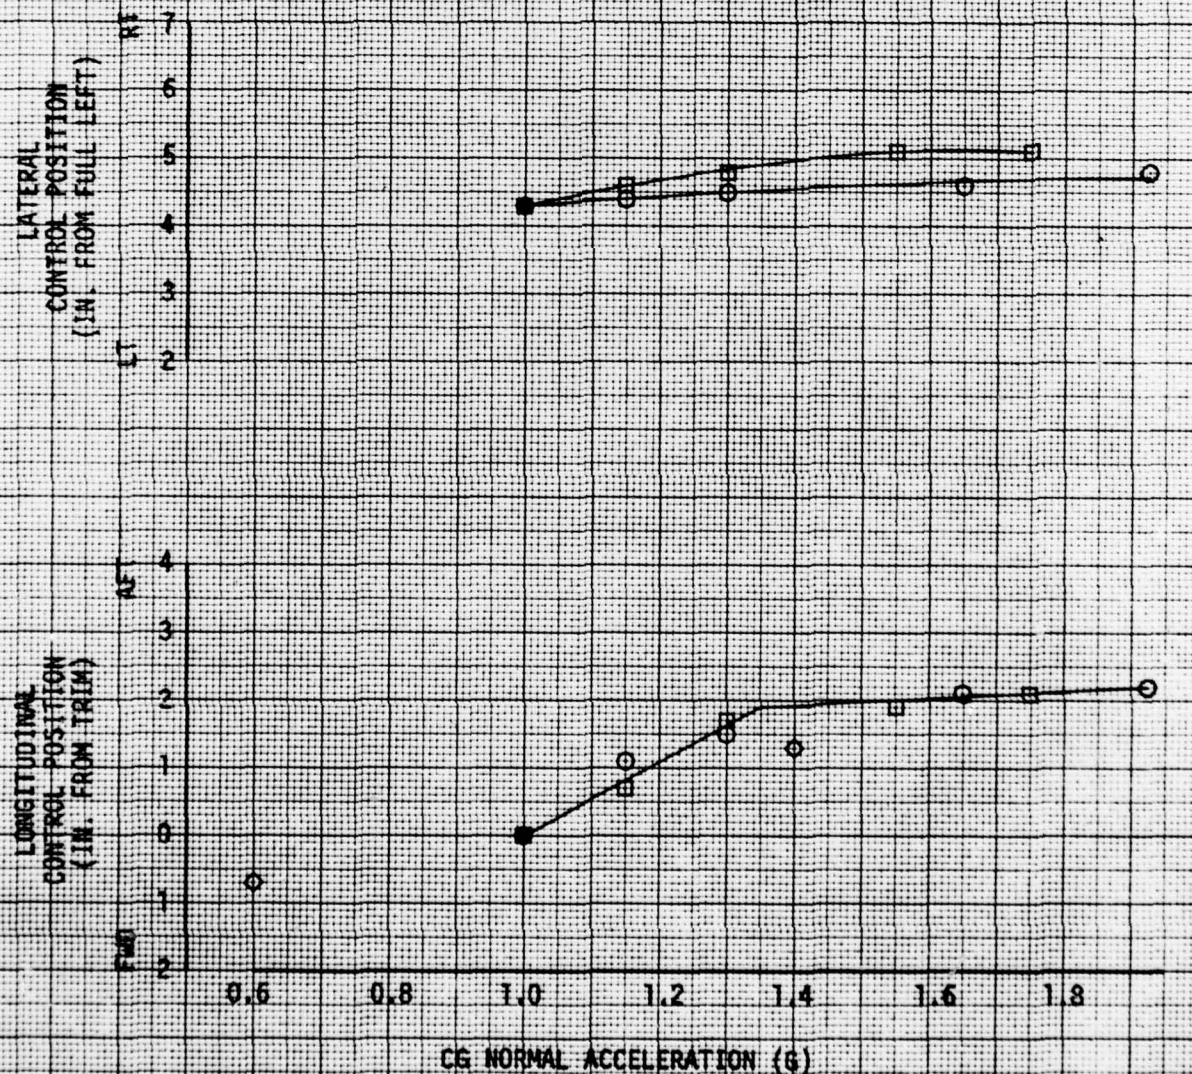
FIGURE 21
MANEUVERING STABILITY

SYM	AVG GROSS WEIGHT (LB)	AVG CG LOCATION		AVG DENSITY ALTITUDE (FT)	AVG OAT (°C)	AVG ROTOR SPEED (RPM)	TRIM FLIGHT CONDITION	CONFIGURATION
		LONG (IN.)	LAT (IN.)					
○	10040	196.3(MID)	0.2 RT	6620	18.0	324	LT TURN	B-TOW
□	9840	196.1(MID)	0.2 RT	6600	18.0	324	RT TURN	B-TOW
○	9760	196.1(MID)	0.2 RT	6600	18.0	324	PULL UP, PUSH OVER	B-TOW

- NOTES: 1. SHADED SYMBOLS DENOTE TRIM POINT AT 1145 SHP.
2. SCAS ON.
3. K-747 ROTOR INSTALLED.
4. ZERO SIDESLIP TRIM CONDITION.

TRIM CALIBRATED AIRSPEED = 105 KNOTS

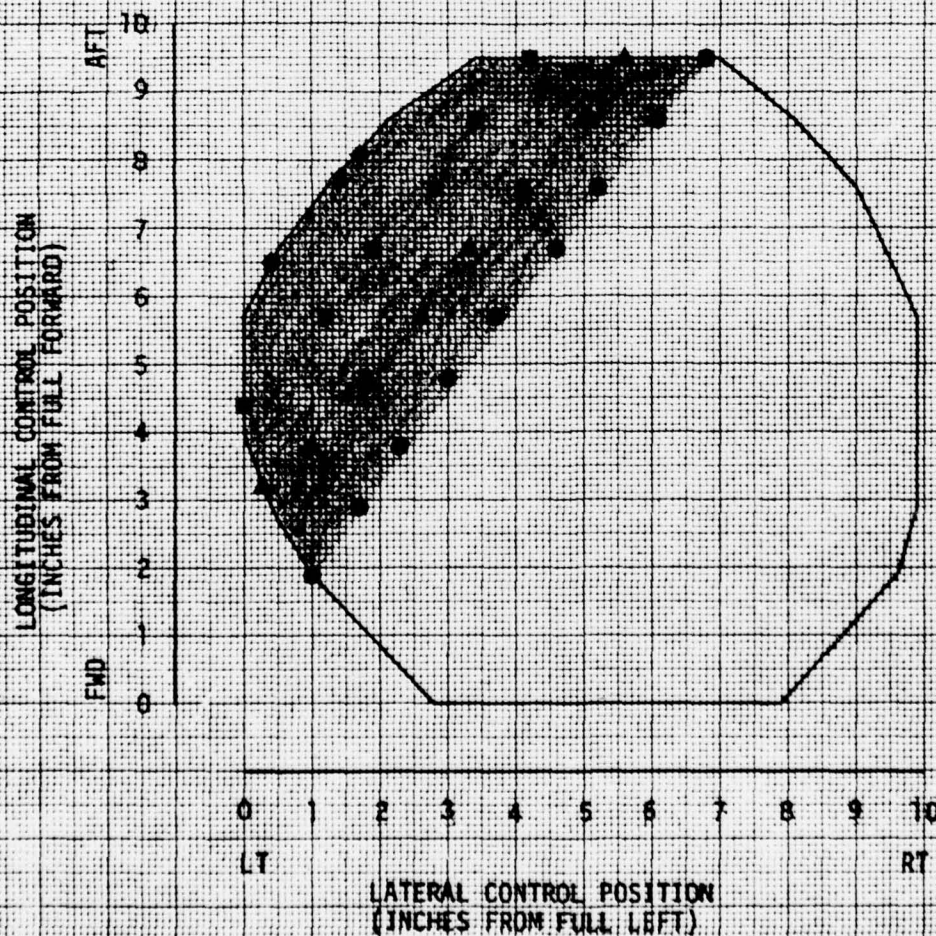
FIGURE 22
K-747 ROTOR TO PYLON FAIRING INTERFERENCE
YAH-15 USA S/N 70-16019

- NOTES:
1. SHADED AREA REPRESENTS K-747 ROTOR AND UPPER PYLON FAIRING CONTACT.
 2. MAXIMUM FLAPPING ANGLE = 12.25°
 3. NO BLADE BENDING
 4. BLADE AZIMUTH APPROXIMATELY 15° ADVANCED FROM AIRCRAFT CENTERLINE
 5. DIRECTIONAL CONTROL CENTERED
 6. CONTROL PATTERN DETERMINED WITH COLLECTIVE CONTROL FULL DOWN
 7. TOTAL CONTROL DISPLACEMENT:
LONGITUDINAL = 9.5 INCHES
LATERAL = 9.9 INCHES
COLLECTIVE = 9.0 INCHES
 8. ● - COLLECTIVE CONTROL POSITION = 9.0 INCHES
▲ - COLLECTIVE CONTROL POSITION = 8.1 INCHES
■ - COLLECTIVE CONTROL POSITION = 7.2 INCHES
◆ - COLLECTIVE CONTROL POSITION = 6.3 INCHES

positions (photo B). The initial points of contact on the blades were the inboard 9 inches of the trailing edge and the lock nut of the drag link retaining bolt. The maximum interference occurred with 100 percent up-collective in combination with left aft cyclic. The interference created an area of contact that extended 20 inches forward of the trailing tip of the pylon fairing and to a depth of 2.25 inches.

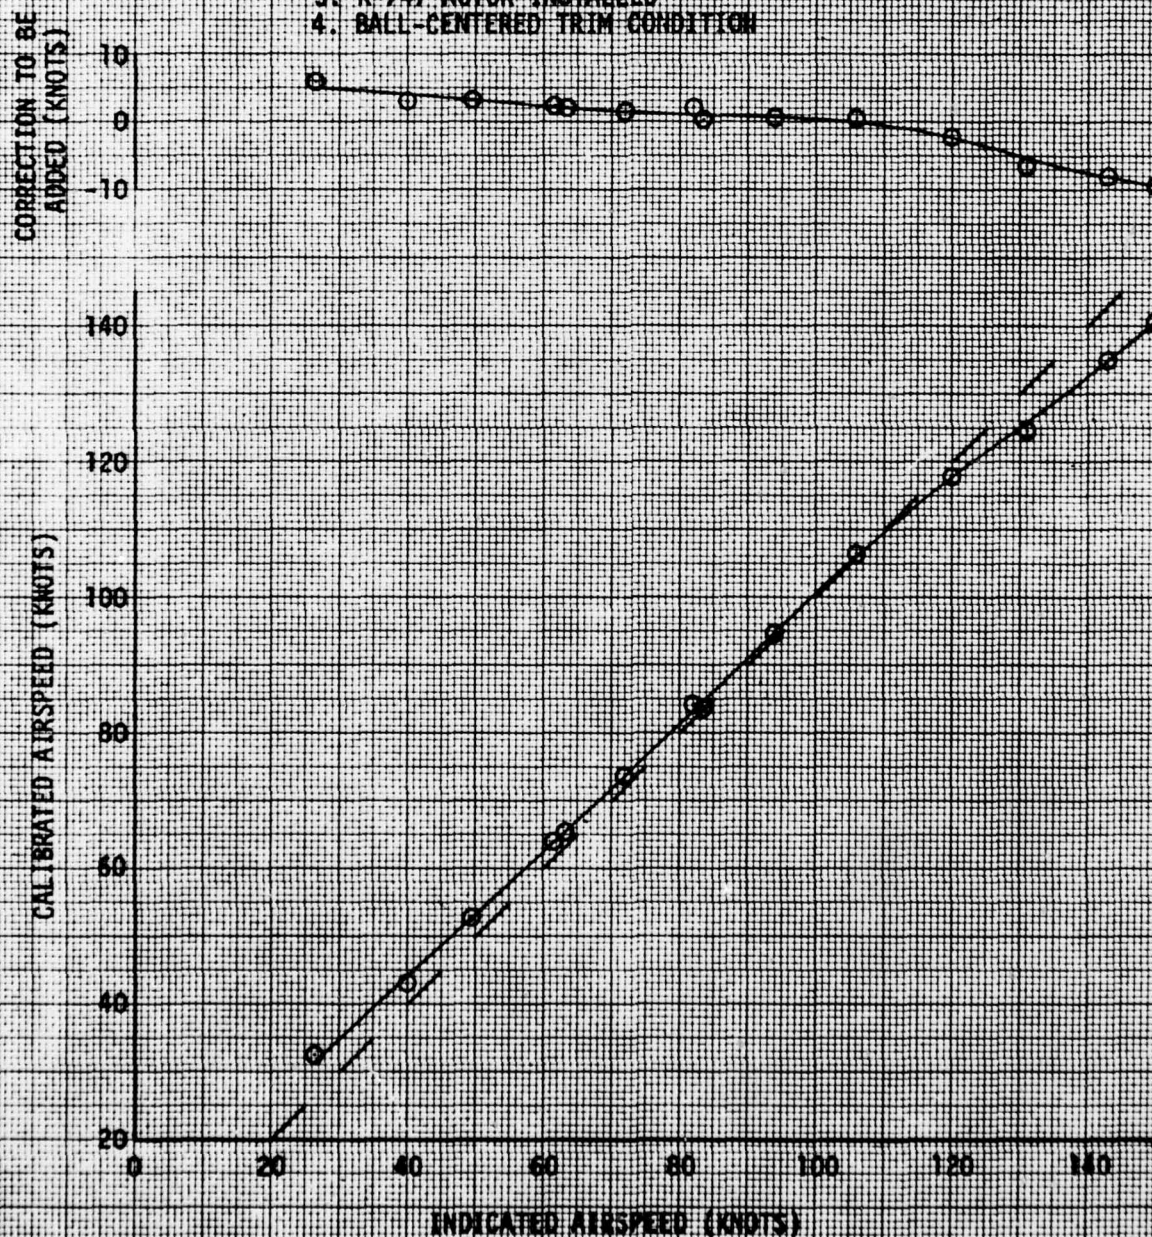
FIGURE 23
AIRSPEED CALIBRATION SHIP SYSTEM
YAH-1S USA S/N 78-16019

AVG GROSS WEIGHT (LB)	AVG CG LOCATION		AVG DENSITY ALTITUDE (FT)	AVG OAT (°C)	AVG ROTOR SPEED (RPM)	CONFIGURATION
LONG (IN)	LAT (IN)					
8320	199.8 (AFT)	2 RT	8220	11.5	324	CLEAN

- NOTES: 1. DATA OBTAINED IN LEVEL FLIGHT
2. PACE METHOD UTILIZED
3. K-747 ROTOR INSTALLED
4. BALL-CENTERED TRIM CONDITION
